1970

FOREST SERVICE, U. S. DEPT. OF AGRICULTURE, 6816 MARKET STREET, UPPER DARBY, PA.

HYDROSEEDING ON ANTHRACITE COAL-MINE SPOILS

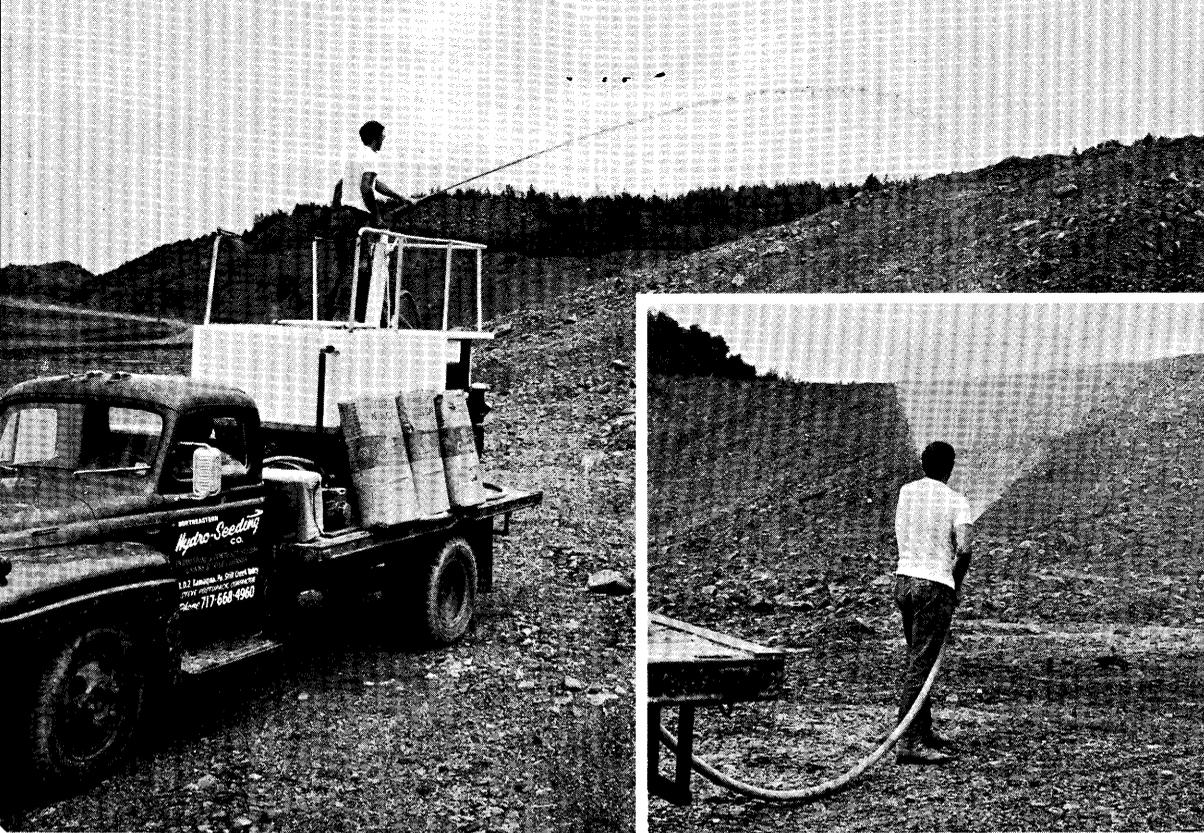
A hydroseeder consists of a tank, a pump, and a nozzle mounted like a gun. (fig. 1). Seed, fertilizer, lime, and mulch are mixed with water in the tank, and the entire mixture is sprayed directly from the nozzle

Figure 1.—Hydroseeder in operation.

onto the area to be seeded. The hydroseeder can be mounted on a truck or on a trailer to be pulled by a tractor.

Hydroseeding.—The hydroseeder — manufactured by the Finn Co.⁴ in Ohio — had a 500-gallon tank, an agitator, pumps, and spraying hoses and nozzles. In preparing the slurry, the tank was first partly filled with water. Then, with the agitator operating, the prescribed quantities of lime, fertilizer, and wood-fiber mulch⁵ were added and mixed for at least 20 minutes. The tank was filled to capacity with water. The seed mixture (table 2) was added to the agitated slurry.

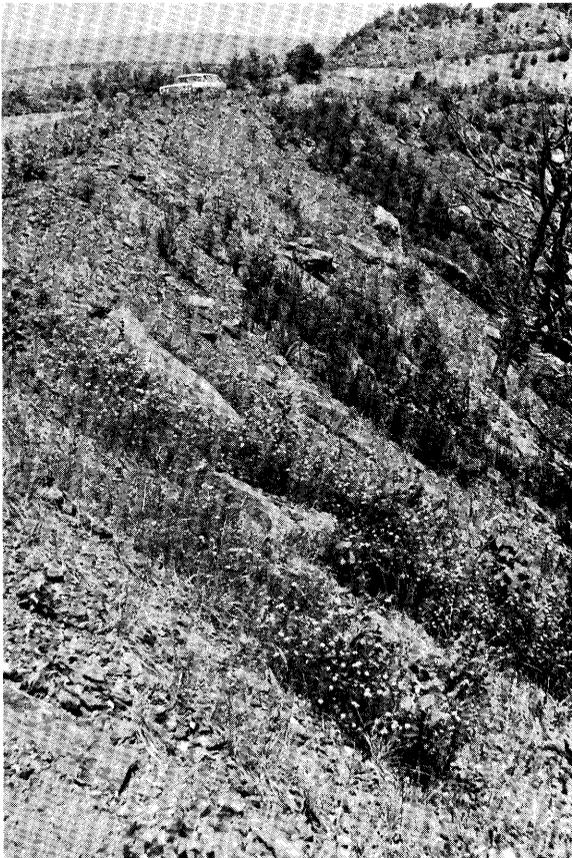
Figure 2.—Series of hydroseeded plots on northeast aspect of ungraded spoil-type III (sandstone and conglomerate) after 3 years. The plots did not reach to the top of the slope and were separated by unhydroseeded strips. From foreground the plots are, crownvetch, lespedeza and lespedeza.

Strip-mine spoils.—The plots hydroseeded on strip-mine spoils performed markedly better. Overall emergence and establishment varied considerably between graded and ungraded sites and between aspects. Some plots produced an adequate stand of at least one species (fig. 2).

Sericea lespedeza — which performed best on northeastern slopes, where it produced a stand with adequate ground cover and good growth for the conditions — grew better than crownvetch on ungraded sites.
